Torn conveyor belt repaired with Belzona elastomers

ID: 9345

Industry: Mining & Quarrying
Application: SHM-Solids Handling Machinery

Customer Location: Huntsville, Ontario
Application Date: April 2023

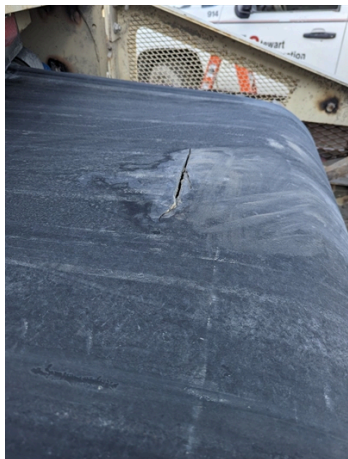
Conveyor belt was ripped and needed repair before being put back in service

Damaged belt

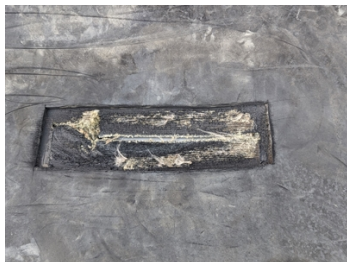
After surface preparation was completed

The ends of the crack were drilled to prevent propagation. Then, the outer layers of the belt were removed and the rubber was properly abraded before application of the Belzona products. The surface was conditioned with Belzona 2911 and then rebuilt with Belzona 2111 reinforced with Belzona 9341

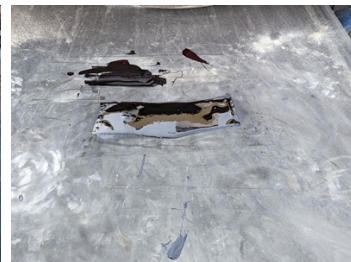
Completed repair
