Propeller Repair and Protection

ID: 9409

Industry: *Marine*
Application: *SOS-Ships and Offshore Structures*

Problem

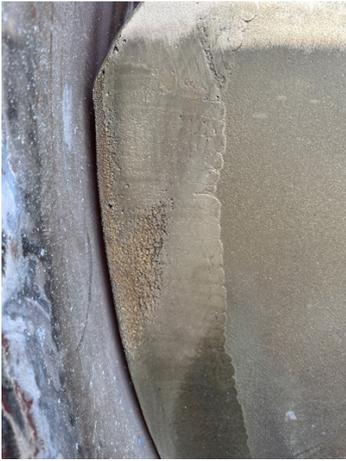
Cavitation damage on propeller and hub

Damage to propeller
