Propeller Repair and Protection

ID: 9409

Industry: *Marine*
Application: *SOS-Ships and Offshore Structures*

Substrate: *Bronze*
Products: *Belzona 1311 (Ceramic R-Metal), Belzona 1341 (Supermetalgilde)*

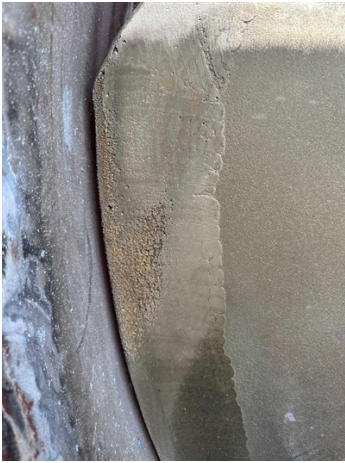
Cavitation damage on propeller and hub

Damage to propeller

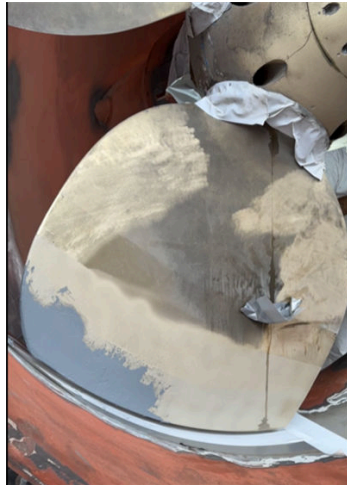
Belzona 1311 applied in areas of cavitation

Belzona 1311 was scrubbed into cavitation pockets then frost blasted after reaching machining stage

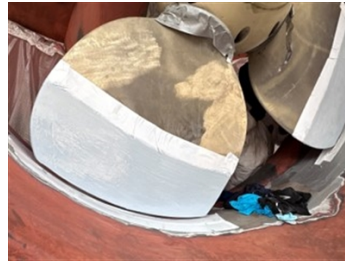
Belzona 1341 grey applied as first coat

1st coat of Belzona 1341 grey was applied at 10mils then a 2nd coat of Belzona 1341 blue was applied at 10mils within the 24hr overcoat window

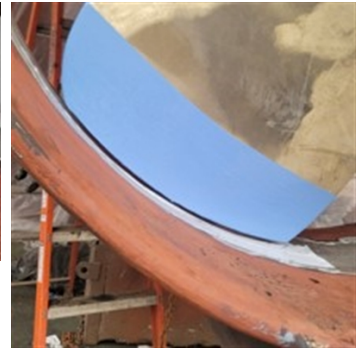
Belzona 1341 blue applied as second coat
