Belzona Rebuilds and Protects an Outboard

ID: 9459

Industry: *Marine*
Application: *ENC-Engines and Casings*
Substrate: *Cast Iron*
Products: *Belzona 1111 (Super Metal), Belzona 1341 (Supermetalgilde)*

Customer Location: *Washington*
Application Date: *May 2019*

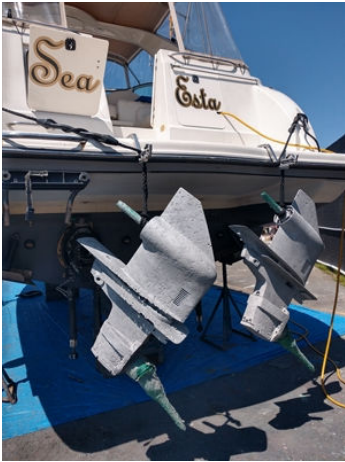
Salt water had corroded this outdrive.

The original coating had failed and allowed the salt water to penetrate and corrode the casings on these yacht outboard drives. The options were to either repair them or replace them. Both units were rebuilt, and protected for under \$2000 USD which would not even bought one replacement outdrive for this yacht.

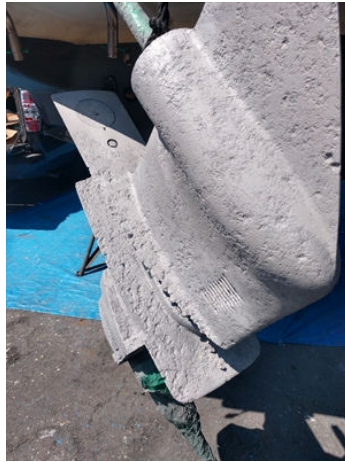
Both outdrives sandblasted and ready for application.

The application areas were grit blasted and washed to remove the salt water. Belzona 1111 was applied by applicator to rebuild the missing areas and smooth out the pitting. Once firm, Belzona 1341 was applied in two coats to prevent further damage.

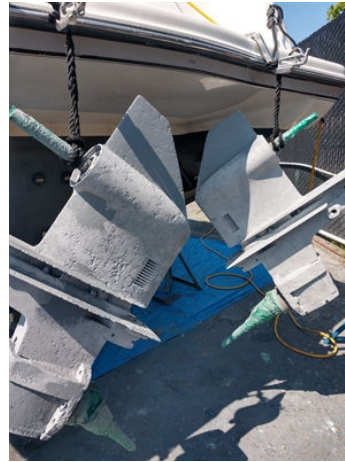
Up close, showing the erosion damage.
