Process Tank Shell Crack Leakage

ID: 9508

Application: TCC-Tanks and Chemical Containment Areas

Substrate: Carbon steel

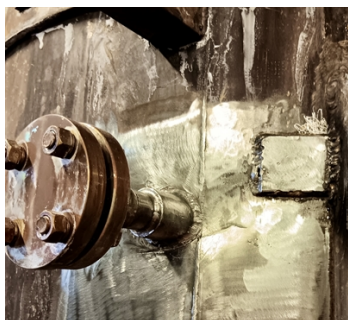
Manual preparation of the C.S. tank shell removing all contaminants and creating a cross-hatch profile for adhesion.

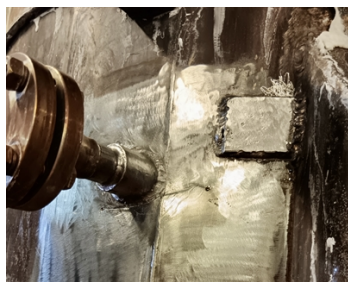
The cracked steel shell was caused by a knock on the nozzle which created an impression and cracked horizontally. The crack was terminated by drilling a small hole at the end of the crack.

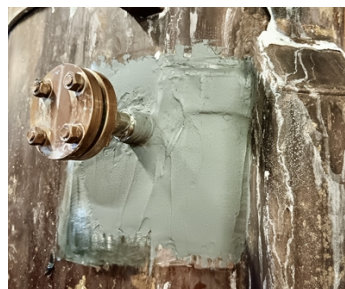
mixed and applied Belzona 1511 Hi-temp, filler to smooth over the prepared area in readiness for the application of Belzona 1983 SuperWrap II

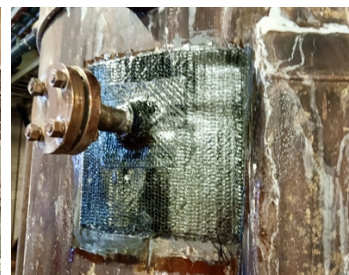
The completed SuperWrap II (1983) patch bonded in place over the Belzona 1511 and onto the steel Tank Shell.
