Belzona repairs cracked flange

ID: 9574

Application: *VPF-Valves, Pipes and Fittings*

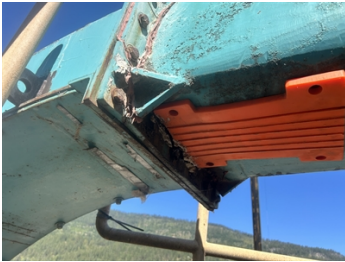
Overtighten flange led to cracked and damaged flange.

Equipment damage

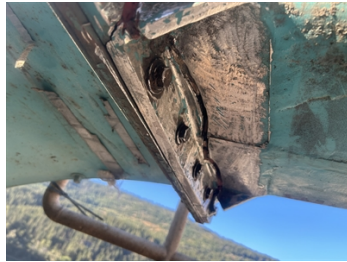
Surface preparation completed

Cracked drill stopped and vee out. Prepares with grinding tools and cracks filled with Belzona 1311 and cloth. Overcoated with Belzona 2141 to provide expansion and contraction protection

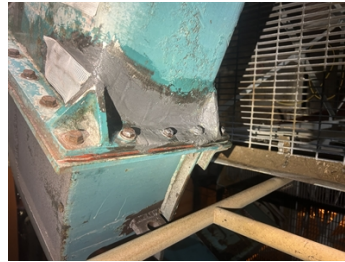
Rebuilt with Belzona 1311

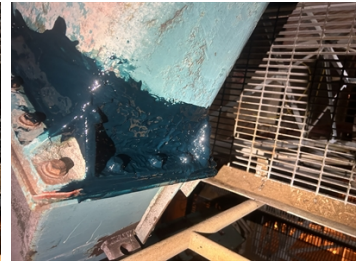
Coated with Belzona 2141 for longevity
