Cracked floor repair and protection

ID: 9577

Industry: Buildings & Structures
Application: FPA-Floor Problem Areas
Substrate: Concrete
Products: Belzona 5231 (SG Laminate), Belzona 5233

Customer Location: Alberta, Canada
Application Date: June 2024

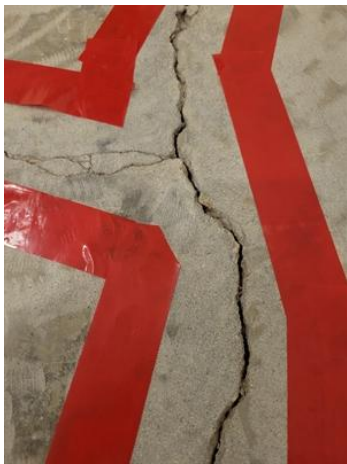
Repair area was defined.

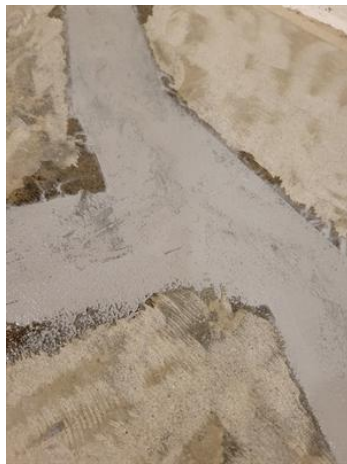
Crack was conditioned with Belzona 4911 and repaired using Belzona 4111.

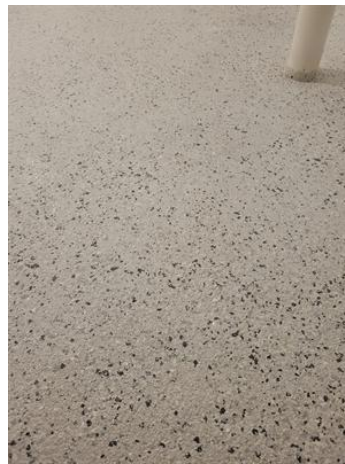
Vinyl flakes applied onto Belzona 5231.

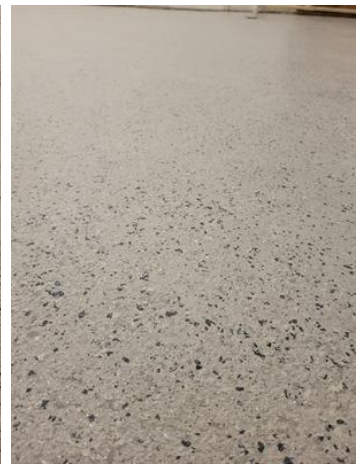
Belzona 5233 was applied as the clearcoat topcoat.
