Repair of damaged impeller edges.

ID: 9599

Industry: *Cement*
Application: *FBC-Fans, Blowers and Compressors*

Substrate: *Carbon steel*
Products: *Belzona 1812 (Ceramic Carbide FP)*

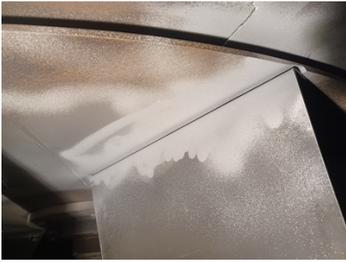
Dusty material causes damage to the edges and blades of the fan.

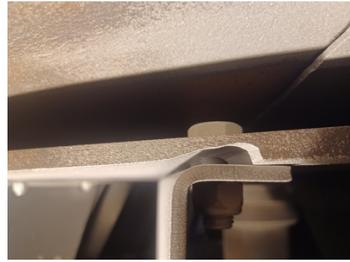
Detail of damage.

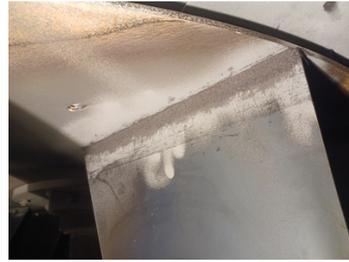
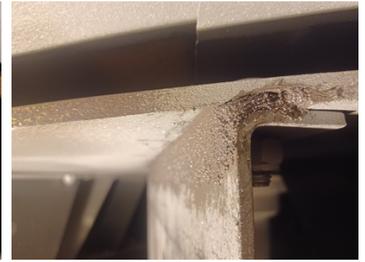
Fixed fan damage using Belzona 1812 product. Repair detail.

Blasting the surface to the required standard Sa 2.5. Surface degreasing.

Application of the product Belzona 1812 in a total thickness of approx. 6000 µm.
