Repair of damaged impeller edges.

ID: 9599

Industry: *Cement*
Application: *FBC-Fans, Blowers and Compressors*

Customer Location: *Slovakia*
Application Date: *January 2024*

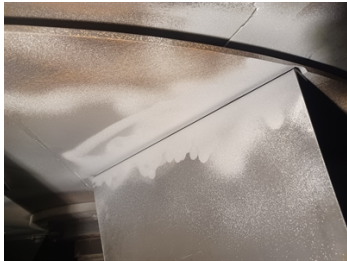
During the distribution of dusty construction materials, the edges and blades of the fan impeller are damaged.

Dusty material causes damage to the edges and blades of the fan.

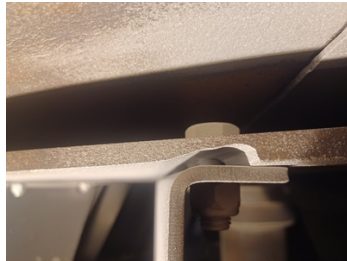
Detail of damage.
