Repair of damaged impeller edges.

ID: 9599

Industry: *Cement*
Application: *FBC-Fans, Blowers and Compressors*

Customer Location: *Slovakia*
Application Date: *January 2024*

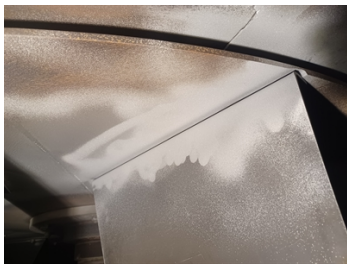
Dusty material causes damage to the edges and blades of the fan.

Dusty material causes damage to the edges and blades of the fan. It was essential to find some solution to protect the fan from abrasion.

Blasting the surface to the required standard Sa 2.5. Surface degreasing.
Application of the product Belzona 1812 in a total thickness of approx. 6000 µm.

The damage reduced production productivity and caused production shutdowns. Application of the product Belzona 1812 in a total thickness of approx. 6000 µm prevented damage to the edges and shoveling of the fan.

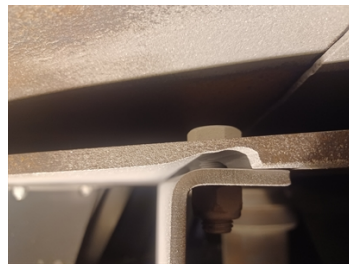
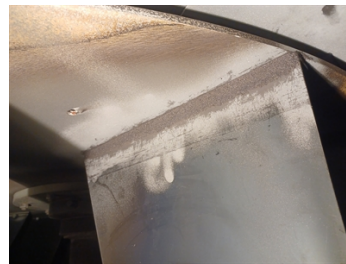
Detail of damage.

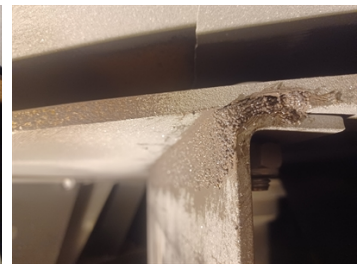
Fixed fan damage using Belzona 1812 product. Repair detail.
