Repair of damaged glass fibre flanges

ID: 9602

Application: *TCC-Tanks and Chemical Containment Areas*

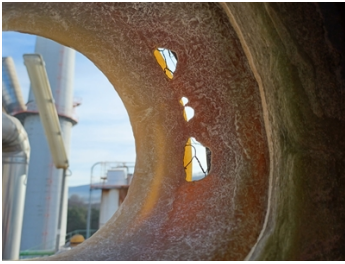
Used tanks suffered severe damage to the glass fiber flanges.

Severe damage to glass fiber necks and flanges

The tanks used by the customer are very old. They were made of glass fiber material. This was severely damaged due to abrasion and chemical attack, to the point where holes formed in the walls.

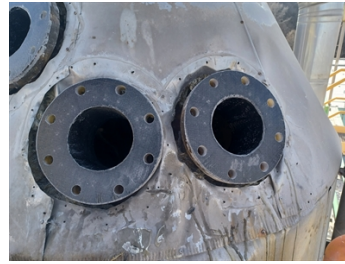
Repaired flanges and necks - ready for use

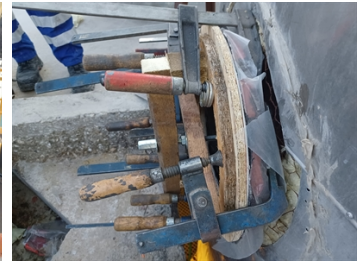
An auxiliary structure had to be built to repair the flanges.
