Repair of damaged glass fibre flanges

ID: 9602

Industry: *Cement*

Application: *TCC-Tanks and Chemical Containment Areas*

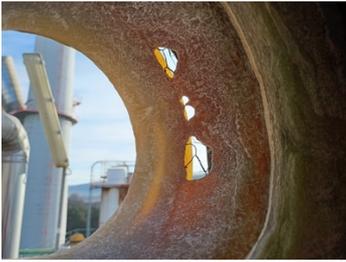
Severe damage to glass fiber necks and flanges

The tanks used by the customer are very old. They were made of glass fiber material. This was severely damaged due to abrasion and chemical attack, to the point where holes formed in the walls.
