Oil cooler repair and protection

ID: 9615

Application: HEX-Heat Exchangers

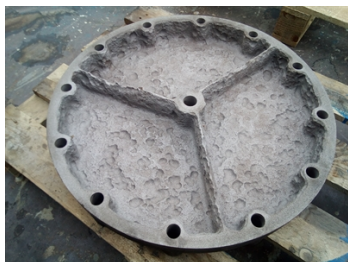
Due to severe corrosion and erosion, the tube sheet and lid were damaged.

Heavily damaged exchanger cover

Surface blasting to the required Sa 2.5 standard with a minimum 75 µm profile. Plugging the ends of coolers with cork plugs. Filling the tube sheet and cover of the cooler with Belzona 1111 Super Metal. Drilling out the plugs + blasting. Application of Belzona 1341 (2 x) in a total thickness of 500 µm.

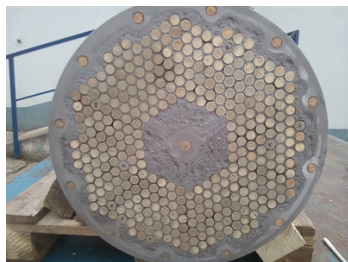
The repair was done using cork plugs.

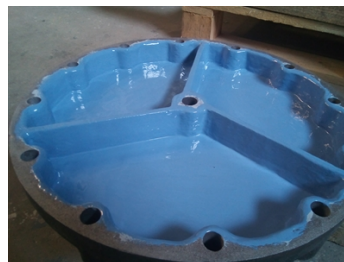
Repaired and protected cover.
