Repair and Protection of Centrifugal Split Casing Pump

ID: 9630

Application: CEP-Centrifugal Pumps

Products: Belzona 1111 (Super Metal), Belzona 1341 (Supermetalglide)

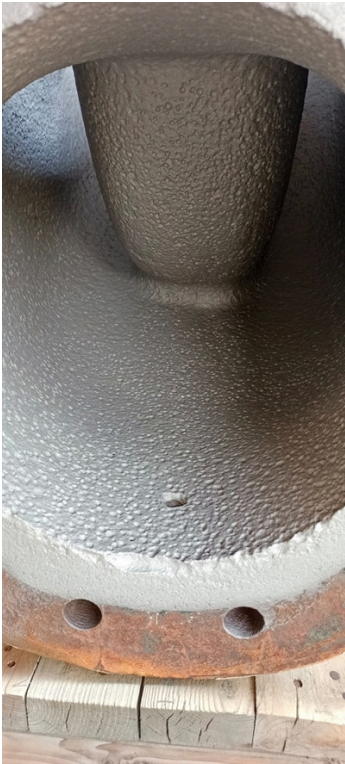
The pump faced erosion and corrosion of the pump casing, resulting in pitting damage across the internal surfaces affecting performance.

Pitting damage appeared after blasting

Damage repaired with the paste grade

Blasting was performed for surface preparation according to Instruction For Use. Belzona 1111 was used to fill pitting and rebuild the ring seat area using the forming technique with Belzona release agent. Finally 2-coat system of Belzona 1341 was applied according to Instruction For Use.

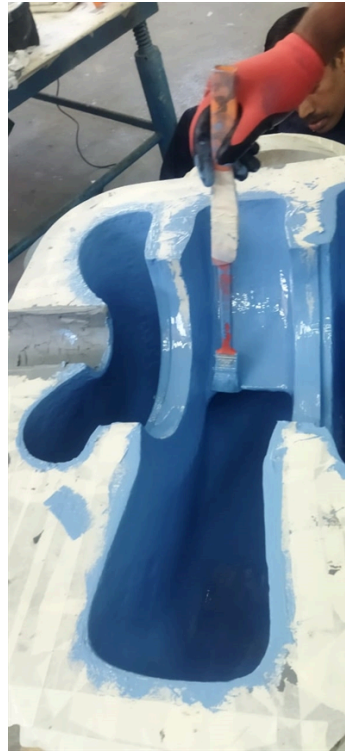
Coating application to the cutwater
