Corroded rotor and end covers

ID: 9636

Industry: Marine
Application: CEP-Centrifugal Pumps
Substrate: Cast Iron
Products: Belzona 1111 (Super Metal), Belzona 1331

Customer Location: Houma
Application Date: October 2024

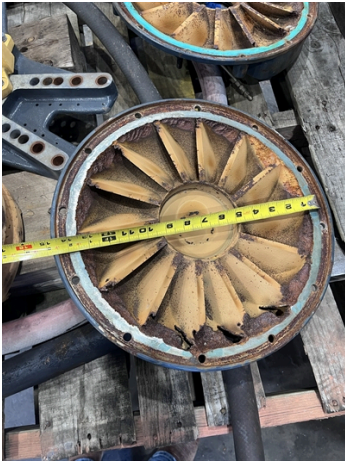
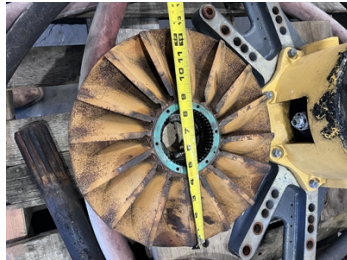
Rotor and end covers corroded due to harsh saltwater environment.

End covers before application. Rotor before application.

Abrasive blasting was performed to create a bonding surface essential for Belzona 1111 to be applied.
