Concrete stitching to damaged Gearbox plinth

ID: 9875

Industry: General Industry
Application: FPA-Floor Problem Areas
Substrate: Concrete
Products: Belzona 4111 (Magma-Quartz), Belzona 4151 (Magma-Quartz Resin), Belzona 4911 (Magma TX Conditioner)

Customer Location: Leicester
Application Date: December 2024

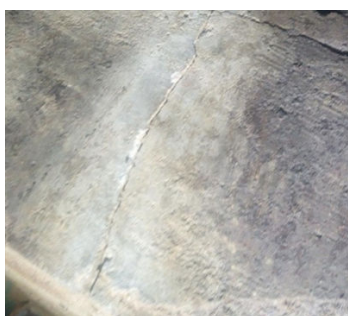
Following the stalling of a very large Ball Mill, the kinetic energy was transferred back to the gear box through the drive assembly. One this energy hit the gearbox, the gearbox kicked back and broke the 10" concrete plinth which the gearbox and drive motor were bolted to, some 30' in the air, above the ground floor

Showing crack to plinth

Structural engineers were consulted, following the advice from the Belzona Area engineer and it was decided that Concrete stitching would provide the solution

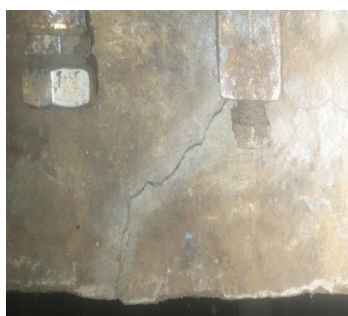
Showing crack on opposite side of plinth

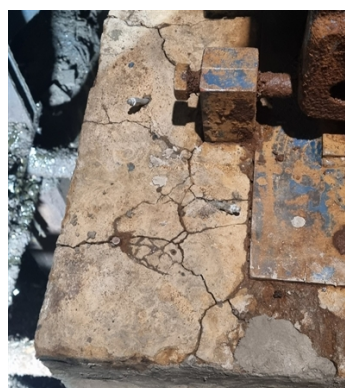
Cracks from above
