BELZONA REPAIRS BROKEN HYDRO ELECTRIC TURBINE RUNNER

ID: 4674

Industry:	Power	Customer Location: Hydro Electric Plant, USA
Application:	CEP-Centrifugal Pumps	Application Date: May, 2007
Substrate:	Cast steel	
Products:	* Belzona® 1311 (Ceramic R-Metal) Belzona® 1322	1 (Ceramic S-Metal) Belzona® 1341 (Supermetalglide)

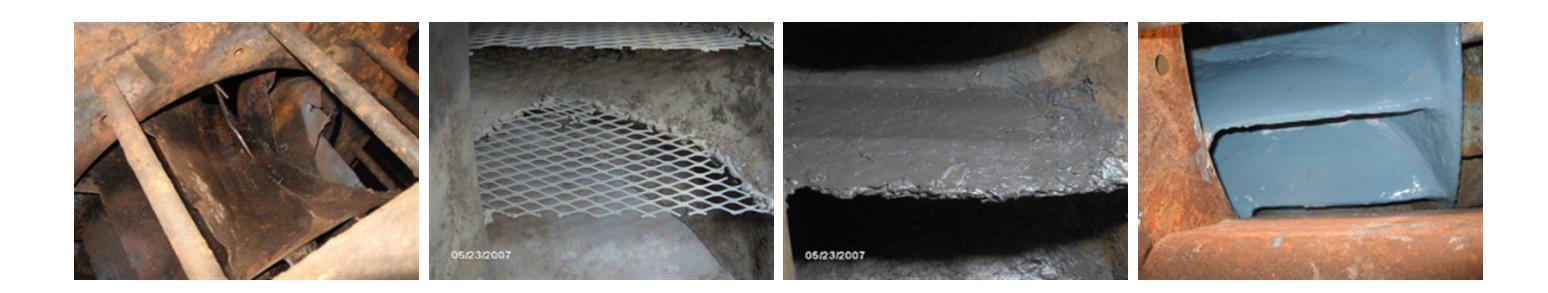
Loss of balance and horsepower.

* Broken runner blade Expanded metal tack welded Blades rebuilt with Belzona® 1311 Completed application after coating runner ,

Wicket gate came loose and fell into turbine breaking three blades on runner.

Application was carried out in accordance with the Belzona Know-How System Leaflets CEP-1 & CEP-3. Expanded metal was tack welded in place before rebuilding with Belzona[®] 1311. Complete runner was coated with Belzona[®] 1311 and Belzona[®] 1341 was applied on top to improve fluid flow efficiency.
