BELZONA REPAIRED CELL ANTENNA MOUNTS ON WATER TANKS

ID: 4821

Application: TCC-Tanks and Chemical Containment Areas

Application Date: September 2013

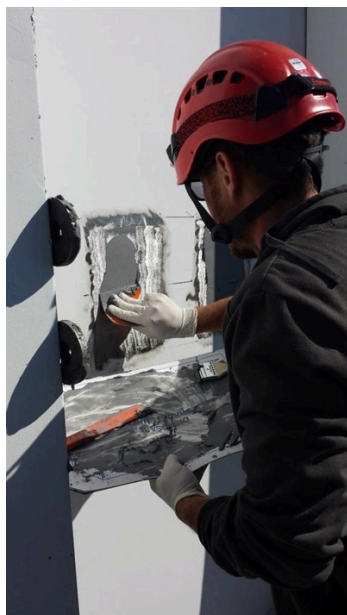
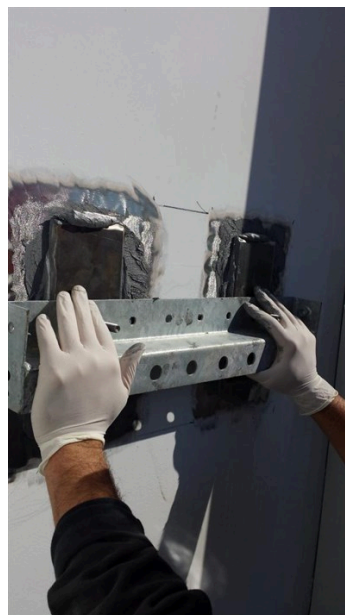
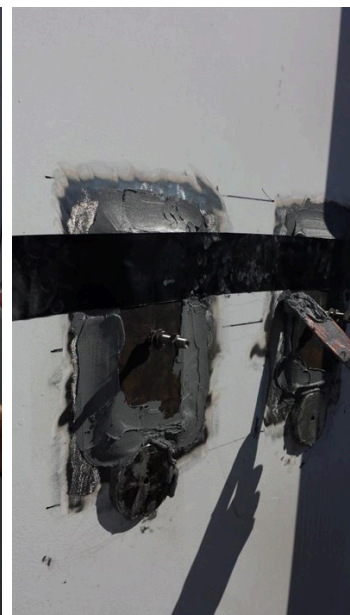
- * Scrubbing Belzona 1111 onto mounting plate. ,
- * Scrubbing Belzona 1111 onto Tank. ,
- * Pressing plates onto tank with cross-bar to align correctly. ,
- * Magnets under the plate to hold it up during cure, tape to keep plates from slipping sideways. ,

Grind 4" x 12" plates, chamfer edges. Grind or MBX bristle blast tank area. Mix and apply Belzona 1111 (or Belzona 1161, depending on the weather) to plates, high in the center. Apply the Belzona product to the tank and press the plate on. Proper alignment is critical. Use the excess Belzona product to build a fillet around the plate edges. We use one or two 90 degree magnets and Gorilla tape to hold the plates in place during cure. Minimum 48 hours before antennae are hung. Most cell phone companies require a Belzona Technical Consultant on site during application to assure Belzona guidelines are followed. The application was carried out in accordance with a modified version of Belzona Know-How System Leaflet TCC-1.
