NO JOB IS TOO SMALL FOR BELZONA

Yamaha YZ 250 cc - 2001

Activities during a motocross race caused a stripped thread. Piece of equipment quite expensive.

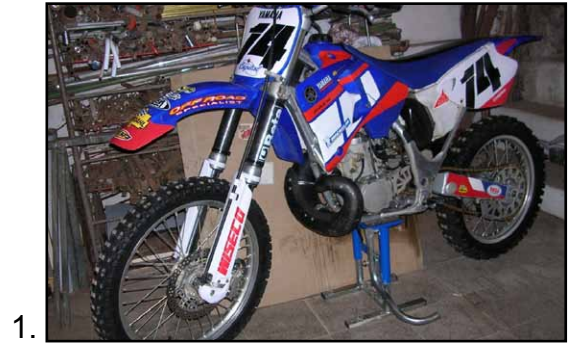
1. Yamaha YZ 250
2. Broken thread
3. Completed work
4. See the rebuilt fillet

Application was carried out in accordance with Belzona Know-How System Leaflet ENC-2. The area was post-cured at 50° C for five hours to ensure that the oil seals were not damaged.

Still in service after months of intensive use.
