## BELZONA ENHANCES PUMP EFFICIENCY

Water supply company, Bulgaria

Double end suction centrifugal water pump

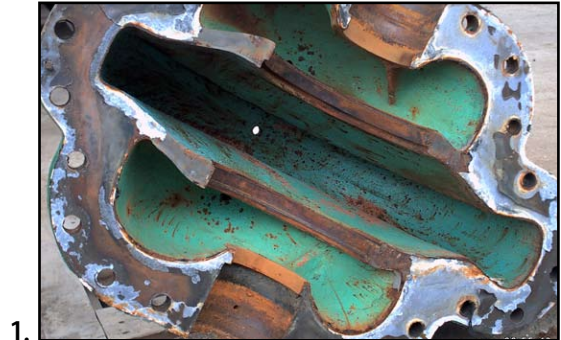
General erosion/corrosion damage leading to reduced pump efficiency

1. Surfaces before application
2. Preparation of the casing
3. Two coats of Belzona® 1341 applied
3. Inspection view after a year in service

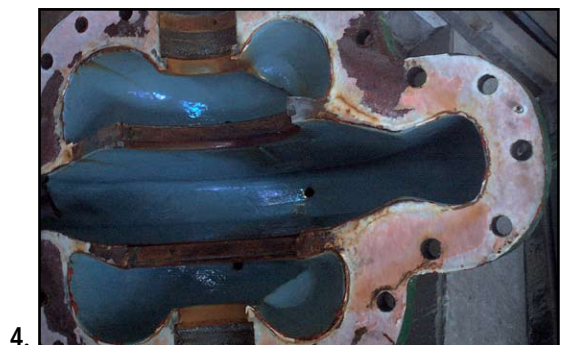
As a result of applied efficiency enhancement coating and further sealing rings seat repair, reduced power consumption was registered and efficiency increased by 9.91%. The inspection after 12 months in service shows the perfect condition of the applied coating.
