## BELZONA REBUILDS WASTEWATER PUMP IMPELLER

Water treatment plant, Des Moines, Iowa U.S.A.

Pump impeller handling raw water.

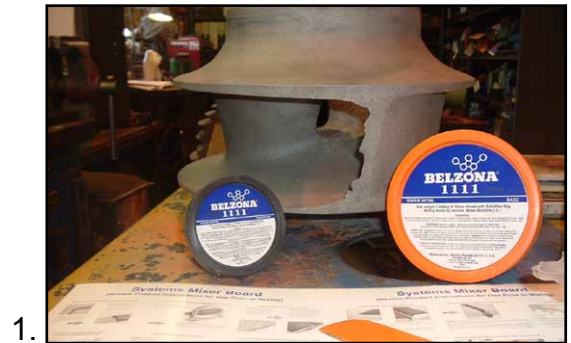
The impeller was badly eroded and damaged due to grit and solids running through the pump

1. Damaged impeller after being baked and grit blasted
2. Impeller with wire mesh in place to support Belzona and help form profiles
3. Profiles restored with Belzona® 1111
4. Rebuilt impeller being balanced
