BELZONA REBUILDS WASTEWATER PUMP IMPELLER

Water treatment plant, Des Moines, Iowa U.S.A.

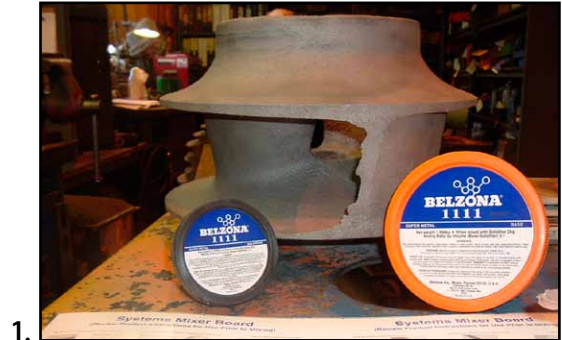
The impeller was badly eroded and damaged due to grit and solids running through the pump

1. Damaged impeller after being baked and grit blasted
2. Impeller with wire mesh in place to support Belzona and help form profiles
3. Profiles restored with Belzona[®] 1111
4. Rebuilt impeller being balanced
