## BELZONA WORKS WHEN THE HEAT IS ON

Smelter, British Columbia, CA

The wall of a fluidized bed roaster where zinc ore concentrate is burned to create zinc oxide.

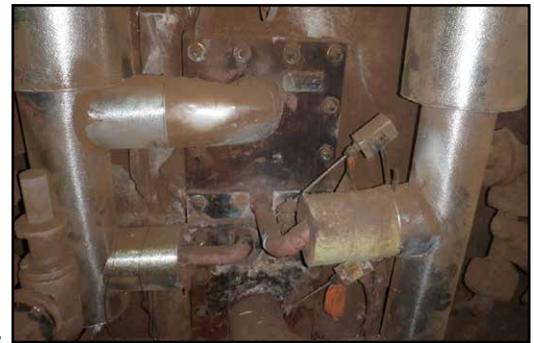
1. Insulation stripped to expose the area; the plates vary from 200°F to 330°F and the exposed piping is over 450°F
2. The leak is coming from behind the center plate, especially the end at the LH side
3. Completed application; the center plate is sealed. Please note the Belzona product on the left end of the plate where a bolt was inserted and extra material was required to seal this live leak of hot SO<sub>2</sub> gas

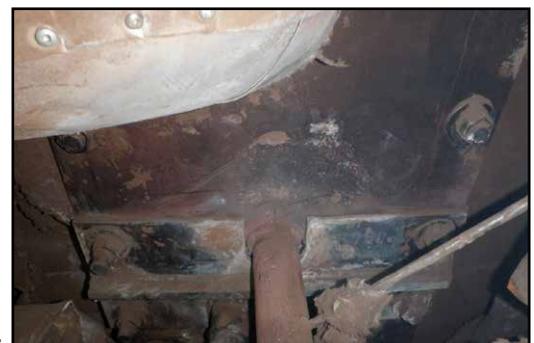
Leaks had formed around a set of plates used to support cooling coils where they pass through the wall of the roaster.
