BELZONA SEALS LIVE LEAK IN LARGE WATER TANK

International Food Processor, UK

April 2013

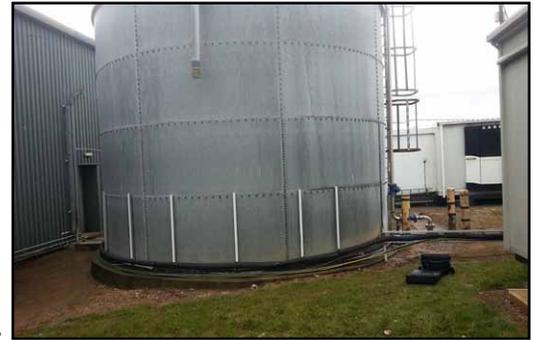
The tank was leaking at the base due to a failed seal, causing local flooding. The customer had tried to seal the leaking area with other products but this had failed and was still leaking. So a local service company recommended they contact Belzona.

1. Large water tank with leaking area at base
2. Leaking area showing water squirting out
3. Leak stopped with Belzona 1291 using clamp to hold it in place against force of leaking water
4. Completed repair coated over with Belzona 1161 & 9341.
