## BELZONA BULKFILL REBUILDS HOSPITAL TRASH PAD

Concrete trash pad for roll-off dumpsters

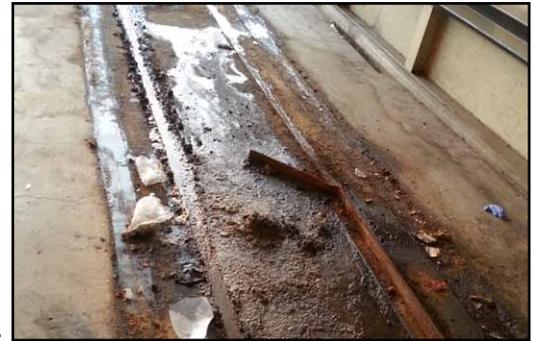
Concrete in roll-off area was deteriorating due to weight and dragging of trash containers. Large hole was a below ground conduit vault. Rain water was entering the vault area and causing electrical hazards.

1. Damaged concrete of the trash pad
2. Removing and scarification of the damaged concrete
3. Application of Belzona 4154 and 4131 as a top coat
4. Complete application
