## MARINE CHILLER UNITS MADE SHIP SHAPE WITH BELZONA

Deep Sea Diving Vessel, Teesside, UK

Marine engine chiller units

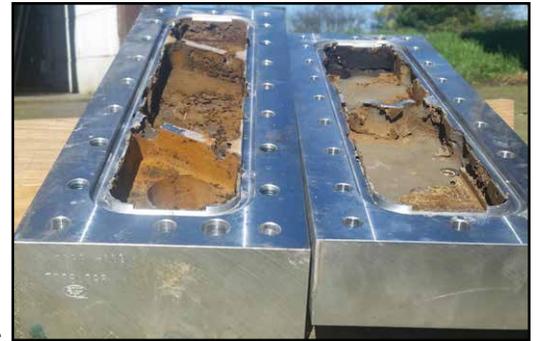
These aluminium chiller units had suffered severe pitting and metal loss caused by microbial attack and bi-metallic corrosion. The newly commissioned ship had a series of 17 chiller units and two of these had been severely damaged in just 8 months of service.

1. Badly corroded chiller block.
2. Corrosion cleaned and roughened back to bright metal.
3. Damage rebuilt with Belzona 1111 & Belzona 1212.
4. Coated with Belzona 1321.
