## BELZONA ROTARY WATER STRAINER WHEEL

Oil Refinery Power Station in Trinidad

Rotary water strainer wheel

Extensive erosion/corrosion to the strainer wheel assembly which is in salt water service

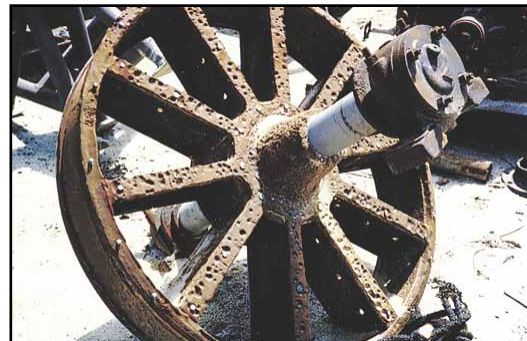
1. The wheel, note the extensive erosion/corrosion
2. Application of Belzona® 1311 in progress
3. Finished application with the gear assembly in place

Belzona® 1341 (Supermetalgilde) was used to hold the blast, and formers were used to rebuild the vanes. The entire wheel was rebuilt with Belzona® 1311 (Ceramic R-Metal) and overcoated with Belzona® 1321 (Ceramic S-Metal). The application saved the operation of the plant since a replacement wheel was no longer available.
