BELZONA KEEPS ICE CREAM FLOWING

Dairy for local Supermarket Chain in Missouri

Several ice cream pumps

Worn gaskets

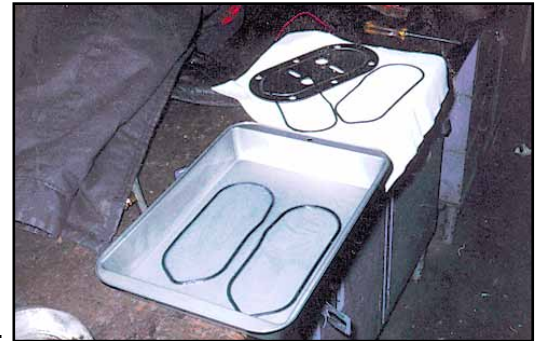
1. New gaskets glued to a cookie tin to create a mold; Belzona® 9411 (Release Agent) was used in the molding process.
2. View of the mold, the plate, and the new gaskets casted from the mold.
