BELZONA REPAIRS SUN DAMAGE ON ROOF

Railway Engineering Workshops in Northern England

Extraction Ducting

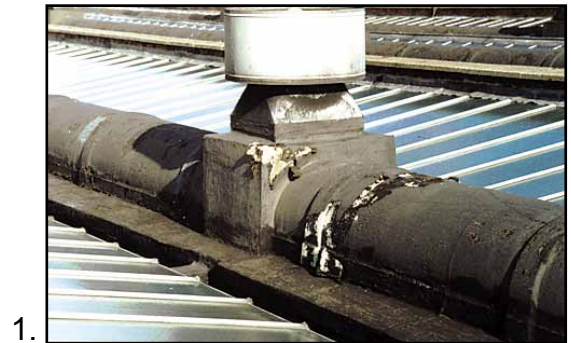
Leaks at seams, bituminous coating is damaged

1. Failed bituminous coating
2. Seam areas addressed
3. Ducting completely protected and sealed

The tar was severely damaged due to the effects of the sun; further application of the bituminous coating would have also failed. Belzona® 3111 solved the problem on the roof.
