BELZONA REFURBISHES THE FLOORS

Airport Food Service in Missouri

Wash area floor for aircraft food service carts

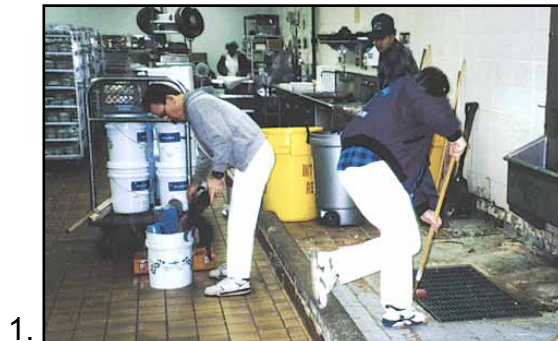
Water was trapped under the tile, causing the tile to break up and providing a haven for bacteria and mold. Pushing the carts over rough, broken, and missing tile posed a serious safety hazard as well.

1. Removing old tile, dirt and concrete
2. Beginning application of Belzona® 4131
3. Job almost completed

Old concrete was removed and 1 1/2" voids were left in several areas. Belzona® 4131 (Magma Screed) was applied over the areas where the minimum depth was 3/8". The application was carried out in accordance with Belzona Know-How System Leaflet FPA-1.
