BELZONA KEEPS THE BEER BREWING

Brewery in Texas

Bromine chemical containment area at brewery

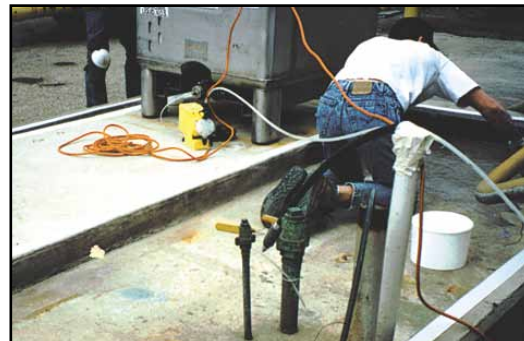
1. Work begins early in the day.
2. Following application of the Belzona® 4911 (Magma TX Conditioner) primer coat, the first coat of Belzona® 4311, red, was applied. Application of the second gray coat is in progress.
3. The finished Belzona® 4311 protective coating is now ready for service.
