## BELZONA REBUILDS BEARING SUPPORTS ON HUGE EXCAVATOR

Open Cast Brown Coal Mine in Poland

Crown bearings of rotational platform of large excavator (superstructure over 400 tons).

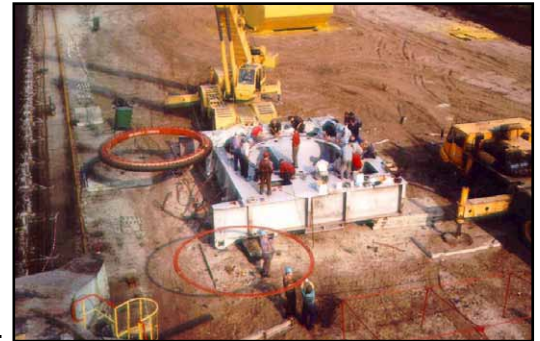
1. General view of the excavator partially dismantled for maintenance
2. Application of Belzona® 1111
3. A team of applicators was required to apply all the Belzona® 1111 quickly, to allow time for the rings to be located
