## BELZONA REBUILDS STERN TUBE BEARING SUPPORTS IN MINIMUM TIME

U.S. Coast Guard Ice Breaker, Seattle

300 ton stern casting containing the bearings supporting the 36" diameter shafts

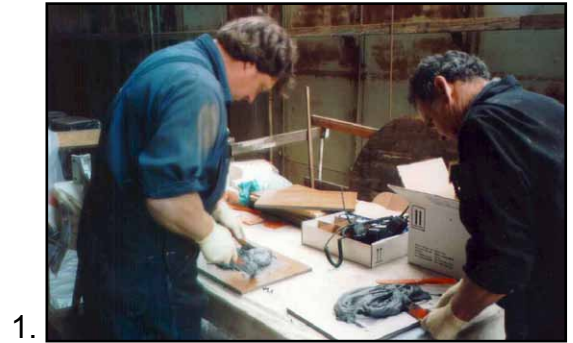
1. It takes a stalwart crew to mix 300kg of Belzona® 1111 in only a few hours
2. Great care was taken to ensure the substrate was correctly prepared prior to the application of Belzona products
3. Application of Belzona® 1111 to rebuild the bearing retaining lands
