## BELZONA BACKHOE SWING ARM REPAIR AT EQUIPMENT RENTAL COMPANY

Backhoe swing arm

All three swing arm bushings had been destroyed and the metal of the bushing bores was severely worn.

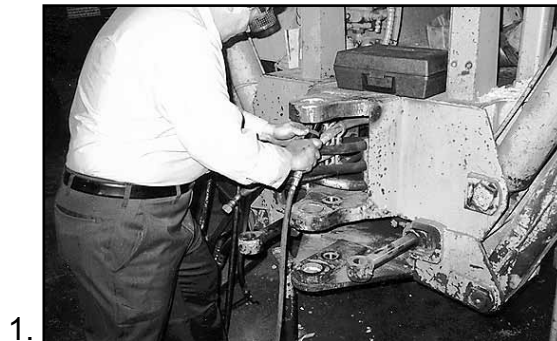
1. Preparation in progress
2. Bushings installed

The application was carried out in accordance with Belzona Know-How System Leaflet MPT-8.
