BELZONA CRUISE SHIP CENTIFUGAL PUMP

Italian Cruise Ship in a Southern California Shipyard, U.S.A.

Main circulating water centrifugal pump

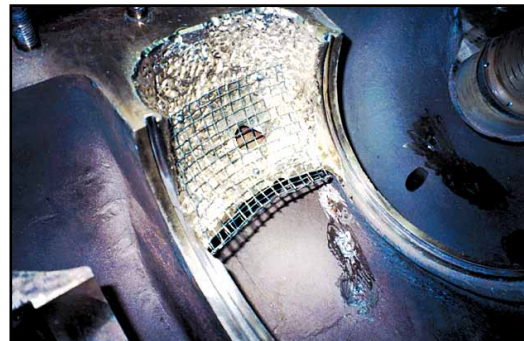
Severe erosion/corrosion damage, evidenced by more than a dozen small holes, and one large hole completely through the casing as well as a loss of up to two inches of the cutwater. The wear ring seats were also eroded in the same area.

1. The pump casing and cutwater after blasting and fitting with expanded metal mesh. Note the hole at the center of the cutwater.
2. Belzona® 1311 being pressed through the mesh and into the surface profile of the bronze.
3. The finished application. Repaired cutwater edge and casing holes. The seal area and rebuilt seating groove is on the right.

Application was carried out in accordance with modified versions of Belzona Know-How System Leaflets CEP-1, CEP-2, and CEP-6.
