BELZONA REBUILDS BEARING PLATES ON VERTICAL BORER

Craven 90" dia. Vertical Borer

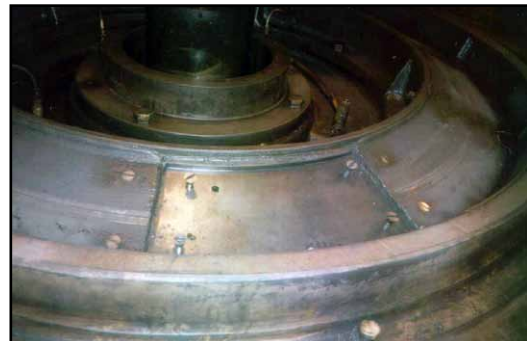
White metal bearing plates badly worn/scored due to oil starvation. Manufacturer of this unit has ceased trading so replacement part is unobtainable.

1. The problem area - excessive wear to white metal plates.
2. Application of Belzona® 1131.
3. Chuck going back into machine to form Belzona® 1131.
4. The finished job with oil grooves cut into Belzona® 1131.

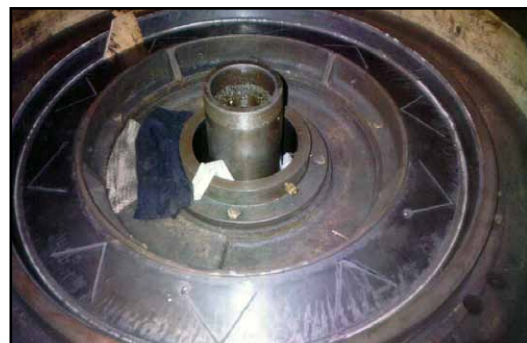
The repaired machine now runs quieter and more smoothly, providing a higher standard of finish to machined components.
