## BELZONA® MAIN INTAKE PUMPS

Nuclear Power Plant in Florida, U.S.A.

Four main intake pumps at power plant

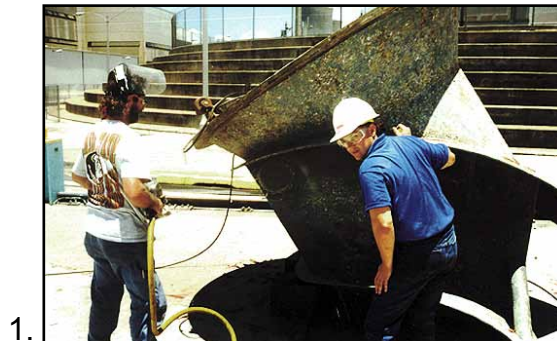
A hole in the diverter caused turbulence and erosion within the pump.

1. Hole in diverter is patched.
2. Work commences.
3. Erosion damage rebuilt with Belzona® 1311.

The hole in the diverter was causing a power drop from 100 to 80%. This was costing the power plant \$140,000 a day. Conventional replacement would have taken 45 days. The Belzona repair was accomplished in 2 days including cure time.
