BELZONA TANK FARM

Chemical Plant in South Alabama, USA

Chemical containment area (5000 sq. ft.)

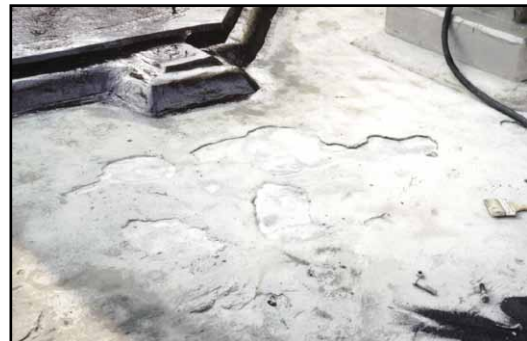
The previous polymeric concrete repair material was damaged by chemical attack. The concrete was repaired and all areas protected.

1. View of damage to polymeric repair compound.
2. Application of Belzona® 4311 in progress.
3. 5000 sq. ft. area protected.
