## BELZONA REFURBISHMENT OF AFTERCOOLER HEADS

Seven heads off air compressor aftercoolers

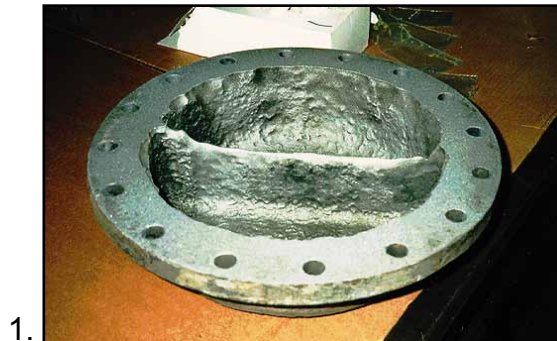
1. Grit blasted cover.
2. Formers in place and coated with Belzona® 9411. Rebuilding with Belzona® 1311 in progress.
3. Rebuilding complete, all parts to be finish coated with Belzona® 1321.
