## BELZONA LOW COST MAINTENANCE OF PRESS PADS

Aircraft manufacturer

March 1997

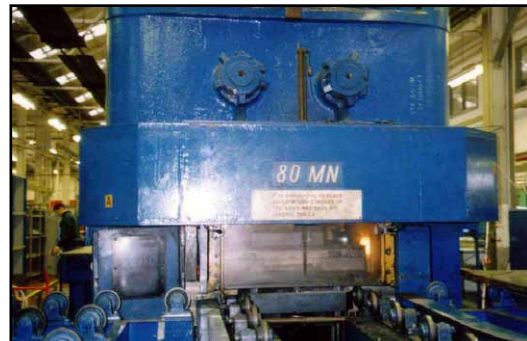
1. General view of the press
2. The resurfacing pad being positioned over the bolster with both surfaces treated with Belzona® 2131
3. Weights in place whilst Belzona® 2131 cures

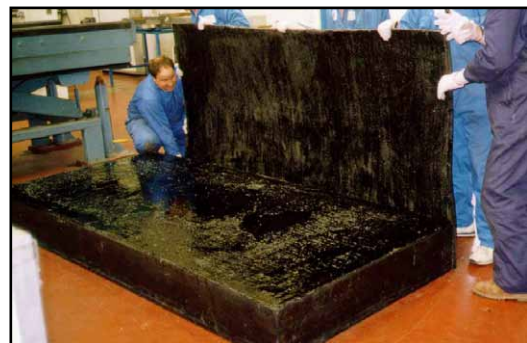
Wear and cutting of the rubber bolster during the forming process leading to loss of accuracy in the formed components.

Instead of replacing complete bolster a 1 inch (25 mm) thick rubber pad is bonded to the surface in accordance with Belzona Know-How System Leaflet GSS-2
