BELZONA EMERGENCY IN A COOLING TOWER

Power Plant in Northwest Florida, USA

Cooling tower containment

Crack (leak) in the containment wall and floor.

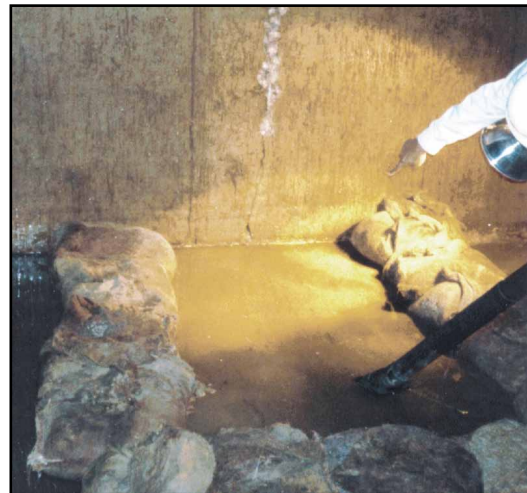
1. The leak; sand bags used to hold back as much water as possible.
2. The completed repair.
