BELZONA ROOF REPAIR, EIGHT YEARS AND HOLDING

Power Plant in Georgia

Expansion joints of slab roof above generators

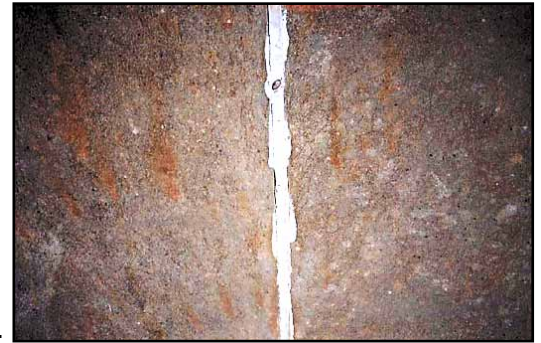
Severe water leakage

1. Joints were leaking.
2. Belzona® 3111 applied 8 years ago and still preventing leakage.
3. Another view of the roof.
