BELZONA PULVERIZER SHAFT

Fossil Power Plant in Alabama

Pulversizer shaft

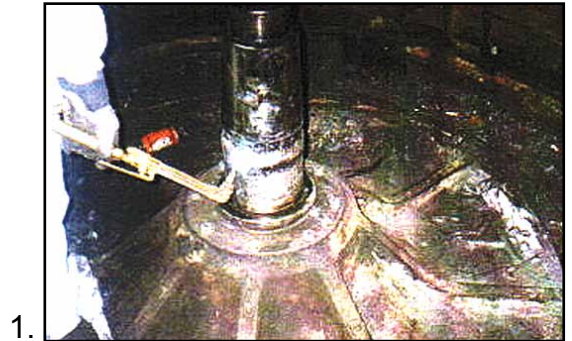
1. Sweating oils from the substrate.
2. The split-form molding technique is used.
3. Formers removed, Belzona® 1311 ready for dressing down.
