BELZONA BALL MILL BEARING PLATE

Coal Fired Power Plant in Alabama

Coal pulverizer-ball mill bearing plate

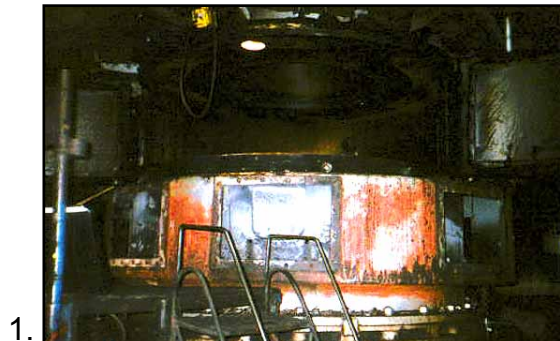
1. Outside view of the coal pulverizer.
2. Holes behind bearing plate of ball mill.
3. Holes sealed, Belzona® 1811 in place.

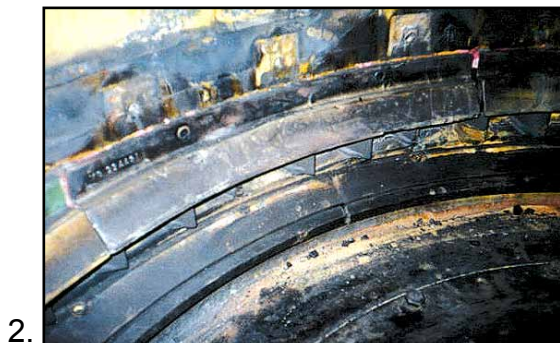
Coal fines cause wear behind the bearing plate resulting in holes and allowing coal to drop out of the pulverizer.
