BELZONA ELECTRICAL CONDUITS MADE SAFE

Coal Fired Power Plant in North Texas

Electrical conduit in demineralization, scrubber, pulverizer and crusher areas

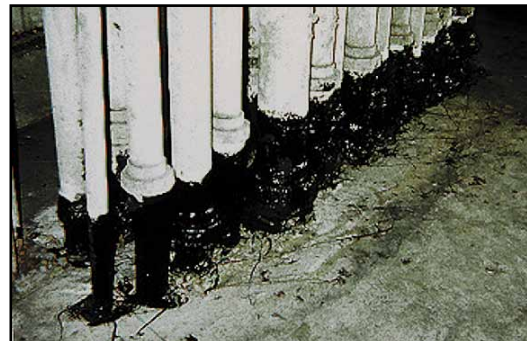
1. Big bank of electrical conduit sealed with Belzona® 2111
2. Another electrical conduit top dressed with Belzona® 4131
3. Close-up view of conduit, also coated with Belzona® 3921 for corrosion protection.
