## BELZONA FLOATING ORANGE HOSE

Offshore Oil Port in the Gulf of Mexico, USA

Floating rail hose

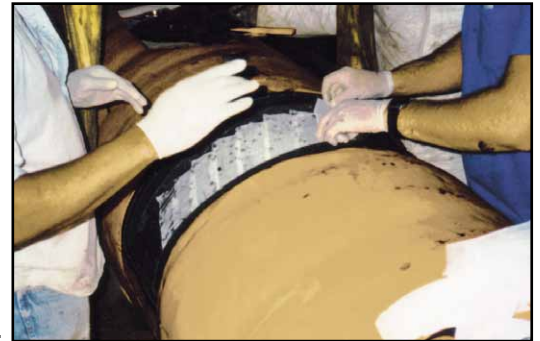
Massive, deep cut in the hose.

1. Repair procedure in progress using Belzona® 9341 and special layering technique.
2. Belzona® 2211 almost cured.
3. Floating hose ready to go.
