BELZONA® 5111 HAS EXCELLENT U.V. RESISTANCE

Paper Mill in Texas - Wastewater section

10,000 sq. feet of small concrete block buildings, pipework and roof.

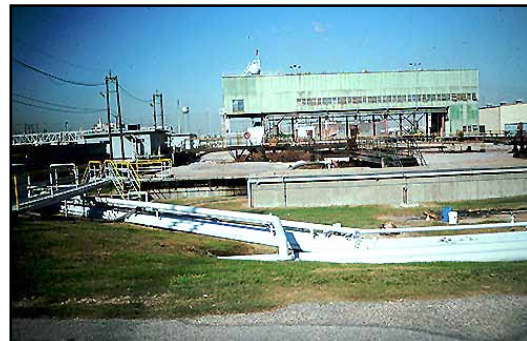
The structures were damaged from exposure to fumes and vapors inherent to the plant.

1. Building outer walls coated with Belzona® 5111.
2. Pipework coated with Belzona® 5111.
3. Even the roof was coated.

After eight years of service, the Belzona® 5111 system continues to provide an aesthetically pleasing coating for the customer.
