## SIMPLE OVERHEAD REPAIRS WITH BELZONA® 4141

Concrete support columns for electricity supply cables at local sub-station

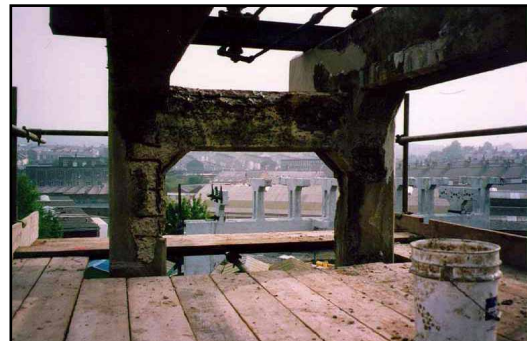
Severe spalling of the concrete accelerated by the acidic atmosphere generated by local industries

1. Close up of the badly spalled concrete
2. Work carried out from simple scaffold platform.
3. Close-up of a rebuilt beam prior to application of Belzona® 5151

Application was carried out using similar techniques to those detailed in Belzona Know-How System Leaflet RPA-2. Repairs were finally overcoated with Belzona® 5151 as preventive maintenance on surrounding concrete surfaces.
