## ROUTINE BELZONA PUMP APPLICATION

SALA Pumps used in the drying plant to transport the clay slurry

Severe erosion of the pump casing and back plates

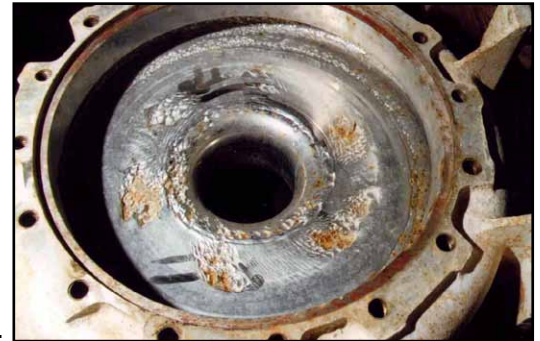
1. Typical casing showing the general erosion damage
2. Belzona® 1311 being applied into the rebate at the extremity of the repair
3. Rebuild of badly eroded cutwater using an Elastomer former to obtain correct profiles
4. The finished casing ready for re-assembly.
