BELZONA CHILLER

Automotive Plant in Ohio, U.S.A.

York chiller condenser

Corrosion problems were beginning on the tube sheet and end covers.

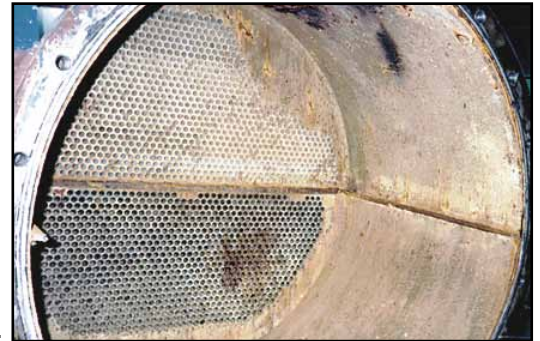
1. Divider plate removed exposing corrosion on the tube sheet and water box.
2. Belzona® 1121 was applied to repair perimeter of cover plate.
3. First coat of Belzona® 1341 on tube sheet face in progress.
4. Completed chiller condenser.
